**Flood Control Project Maintenance  
Levee Inspections**

**Fall 2018 Levee Maintenance Deficiency Summary Report**

**Reclamation District No. 2031 Elliot**

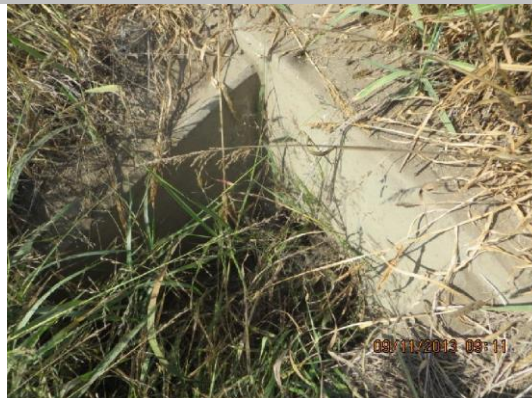
Photo 1 of 2 : UCIP\_FA\_2018\_20024\_33924.jpg

LM Start	0.35	Rating **	A/W	Issue No.	983
LM End	0.35	Issue Type +	Ma	Location *	
Category	Supplemental			GPS Latitude/Longitude	
				Start	End
Item	DWR UCIP LMA Responsibility			37.705932 °	37.705932 °
				-121.157985 °	-121.157985 °
DWR ID	20437				
Comment Code					
Inspector Comment					
FS_ID:20024					
DS_ID:20437					
EP_NO: N/A					
Repair Type: No Action Needed					
Crossing Status: Found					
UCIP Comments:					
FIELD_STRUCT_DESC: 24-inch corrugated metal drainage pipe through the levee, 3.5 feet below the crown. Concrete U-shaped headwalls on both ends. Flap gate on the waterside (WS) end. Installed by USACE in 1966. [Additional Reference(s): DWR Levee Log, 2005. USACE San Joaquin O&M Manual 4, June 1968, (HLM 0.36)].					
FS Date: 9/11/2013

Concrete headwall on LS slope.

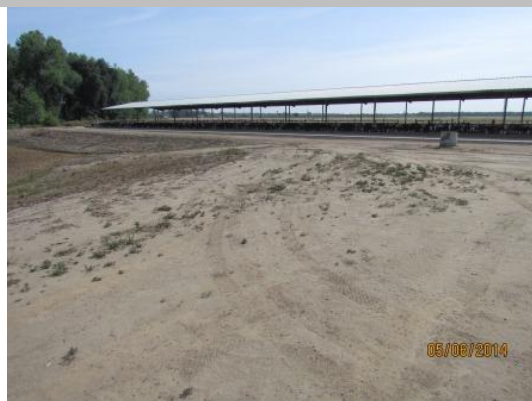
Photo 1 of 1 : FA\_2018\_RD2031\_307\_126\_20180918\_00040.jpg

View of the material placed on the waterside levee slope to build up the levee and increase the levee crown. Spring 2014.

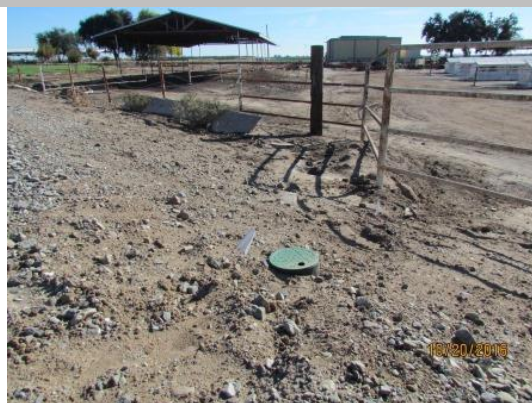
Photo 1 of 1 : FA\_2018\_RD2031\_307\_40\_20180918\_00019.jpg

View of the wire crossing the levee about 4 to 6 inches deep into the levee slope and crown. Irrigation box identifies the crossing location.

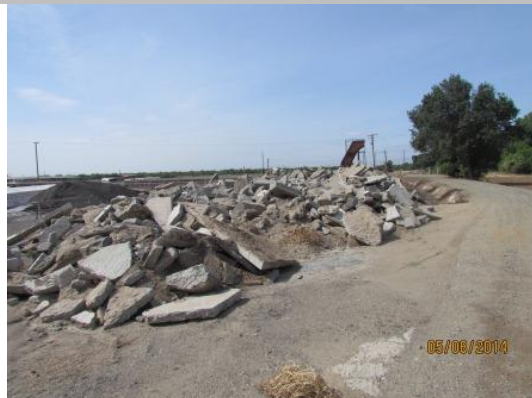
Photo 1 of 1 : FA\_2018\_RD2031\_307\_127\_20180918\_00041.jpg

View of the concrete debris stockpiled at the landside levee toe.

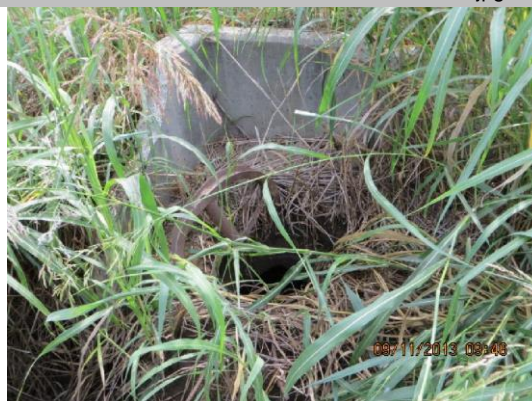
Photo 2 of 3 : UCIP\_FA\_2018\_20046\_33945.jpg

Concrete headwall and damaged alfalfa valve on WS toe.

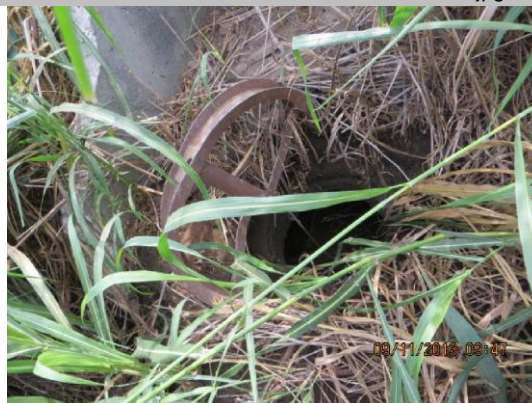
Photo 3 of 3 : UCIP\_FA\_2018\_20046\_33944.jpg

Damaged alfalfa valve.

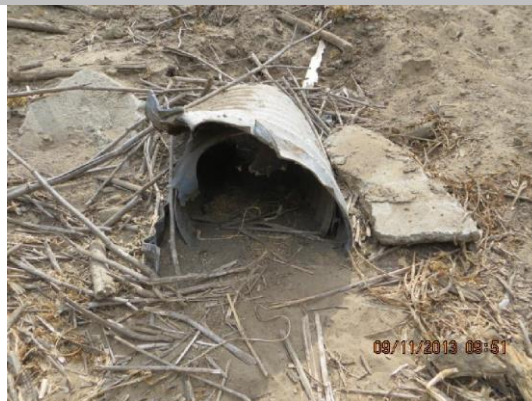
Photo 1 of 3 : UCIP\_FA\_2018\_20047\_33950.jpg

LM Start	0.75	Rating **	M	Issue No.	986
LM End	0.75	Issue Type +	En	Location *	
Category	Supplemental			GPS Latitude/Longitude	
				Start	End
Item	DWR UCIP Field Study			37.701552°	37.701552°
				-121.161883°	-121.161883°
DWR ID	20441				
Comment Code					
Inspector Comment					
FS_ID:20047 DS_ID:20441 EP_NO: N/A Repair Type: Non-Urgent Crossing Status: Found UCIP Comments: This pipe appears abandoned and if so, should be done so appropriately. FIELD_STRUCT_DESC: 15-inch corrugated metal irrigation pipe through the levee, 4 feet below the crown. Flashboard slots on the landside (LS). Installed by USACE in 1966. [Additional Reference(s): DWR Levee Log, 2005. USACE San Joaquin O&M Manual 4, June 1968, (HLM 0.75)]. FS Date: 9/11/2013

Damaged CMP pipe on WS slope.

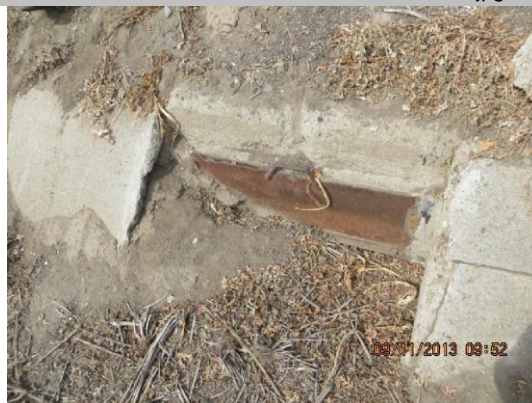
Photo 3 of 3 : UCIP\_FA\_2018\_20047\_33948.jpg

Closed slidegate at concrete headwall in concrete channel on LS shoulder.

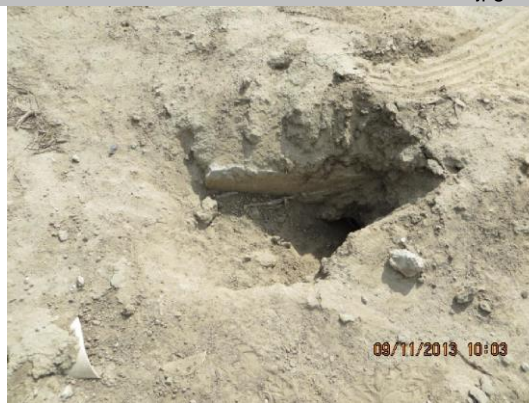
Photo 3 of 3 : UCIP\_FA\_2018\_20049\_33954.jpg

Concrete headwall on WS shoulder buried.

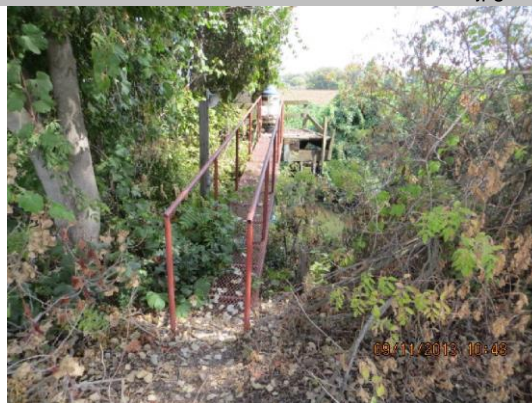
Photo 2 of 3 : UCIP\_FA\_2018\_20085\_34009.jpg

Pump on pier on WS slope.

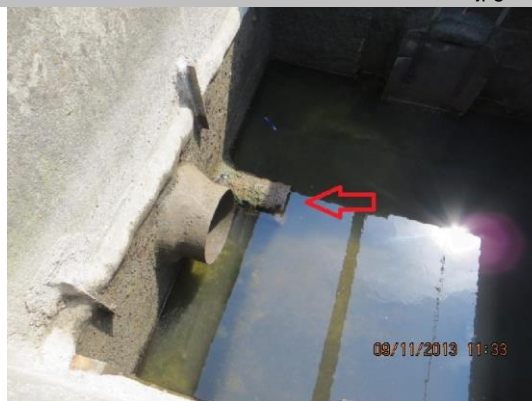
Photo 3 of 3 : UCIP\_FA\_2018\_20085\_34008.jpg

Pipe visible inside concrete distribution box on LS shoulder.

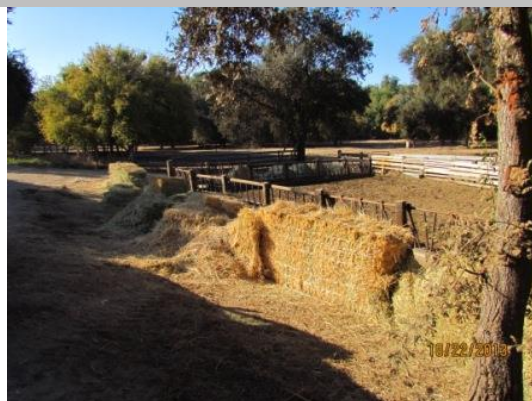
Photo 1 of 1 : FA\_2018\_RD2031\_307\_37\_20180918\_00017.jpg

View of the hay bails at the waterside levee toe.

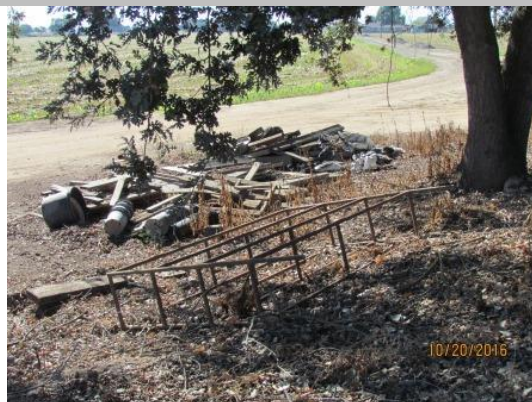
Photo 1 of 2 : FA\_2018\_RD2031\_307\_53\_20180918\_00030.jpg

View of the debris at the landside levee toe.

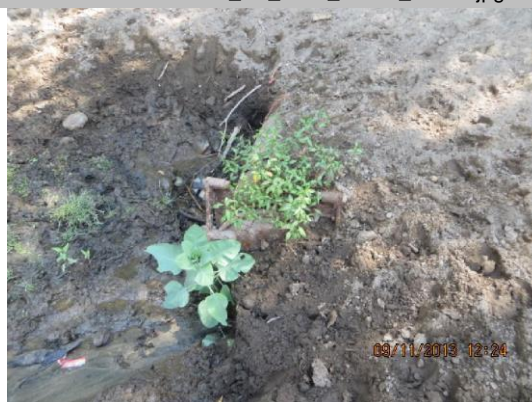
Photo 3 of 3 : UCIP\_FA\_2018\_51340\_39001.jpg

Flapgate partially blocked by soil on WS toe.

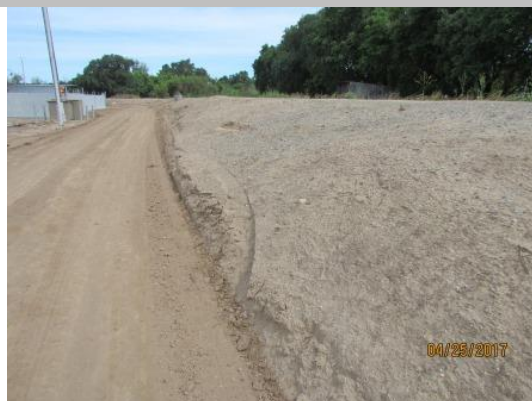
Photo 1 of 1 : FA\_2018\_RD2031\_307\_55\_20180918\_00032.jpg

View of the levee toe cut. Looking downstream.

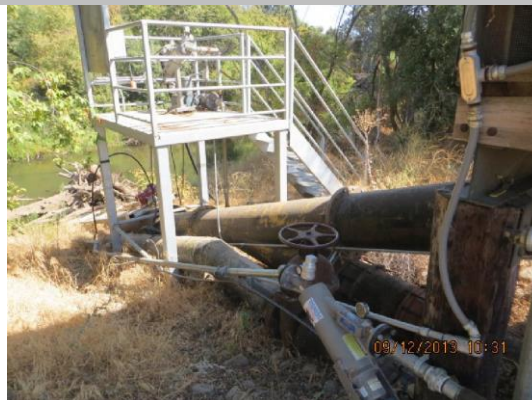
Photo 3 of 3 : UCIP\_FA\_2018\_20667\_34748.jpg

Pipe with debris flow buildup at inlet visible on WS toe.

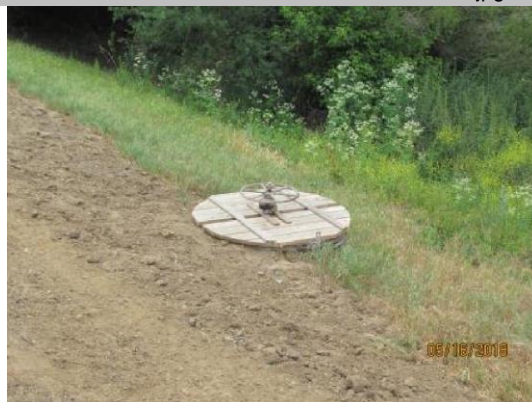
Photo 1 of 3 : UCIP\_FA\_2018\_52629\_77560.jpg

5/17/2018- Newly installed lid.

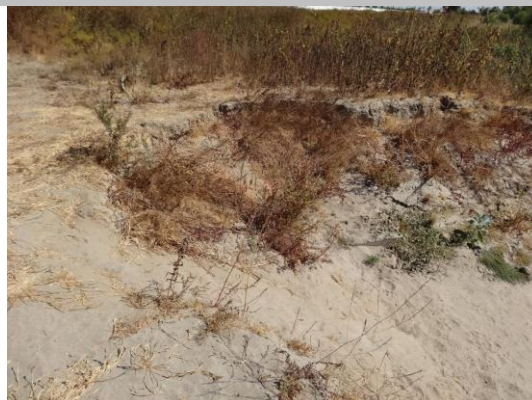
Photo 3 of 4 : FA\_2018\_RD2031\_308\_1\_20180918\_00003.jpg

Close view of the pocket erosion.

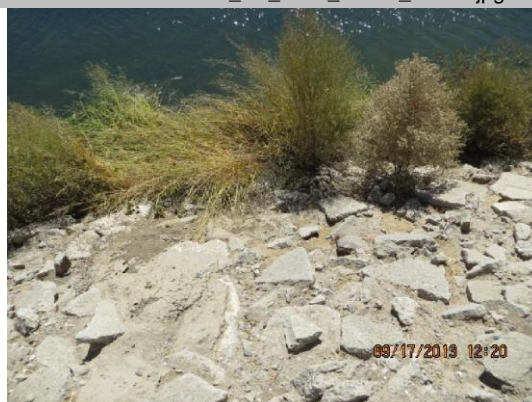
Photo 2 of 3 : UCIP\_FA\_2018\_22872\_39035.jpg

Concrete debris placed over pipe location on WS shoulder.
